PROACTIVE
*A Hurricane Preparedness Program
for Temporary Re-Roofing*

Installation Process

Service:	Temporary Emergency Roof
Size:	30,000 s.f.
Installation:	2 days
Project:	Commerce Park Distribution Center
Location:	Tampa, Florida
Facility Type:	Distribution Center
Owner:	Prologis

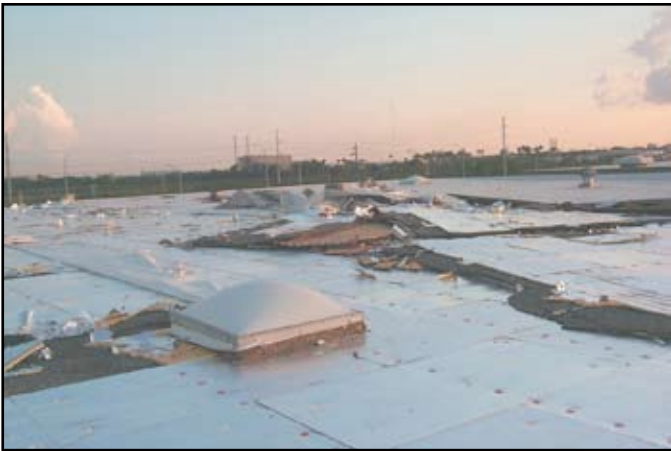
Twenty five thousand square feet of single ply roof membrane is completely blown off in the storm.

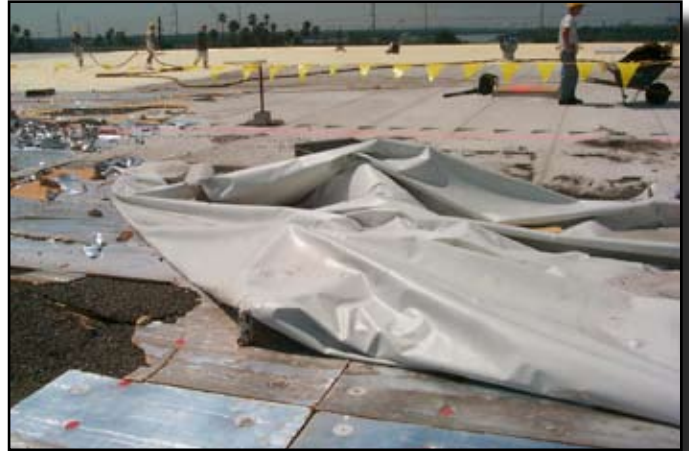
Torn and ripped single ply roof membrane.

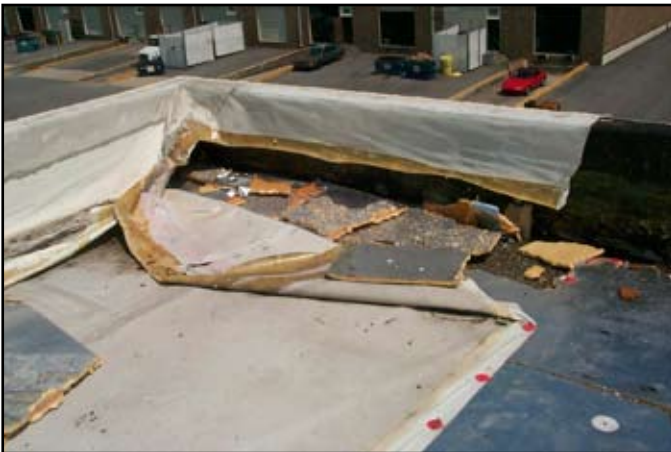
Missing wall flashing.

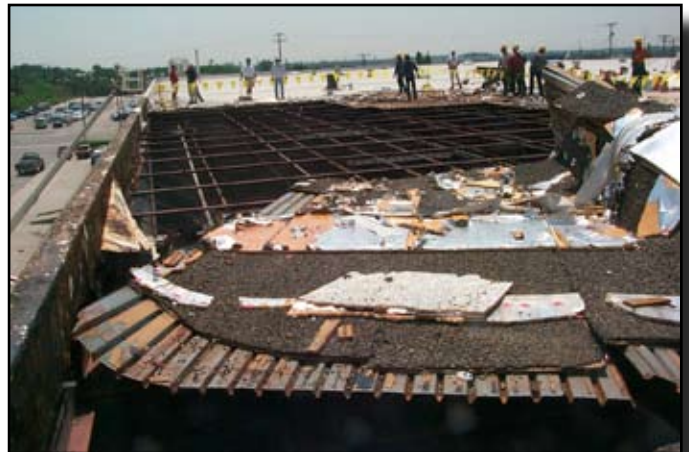
5,000 s.f. of metal deck is ripped from the structural purlins. Falling debris caused an unsafe condition inside the building.

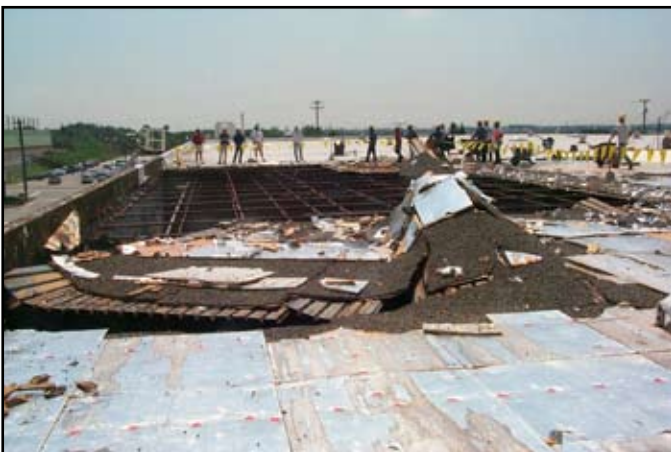
Metal deck is crumpled and lying in piles on the roof.

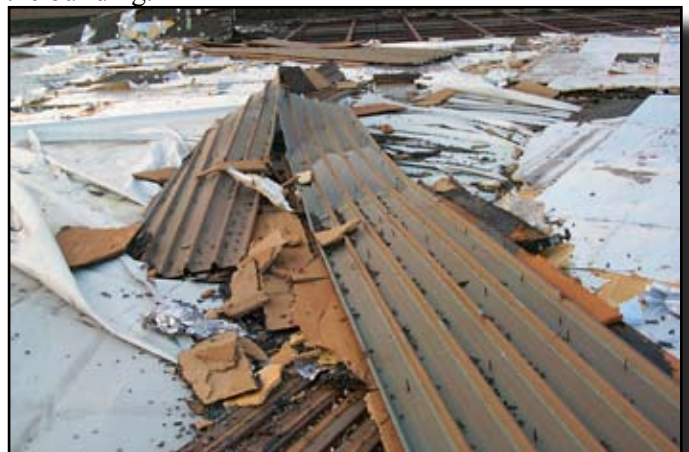
Sections of metal deck is scattered around the roof.

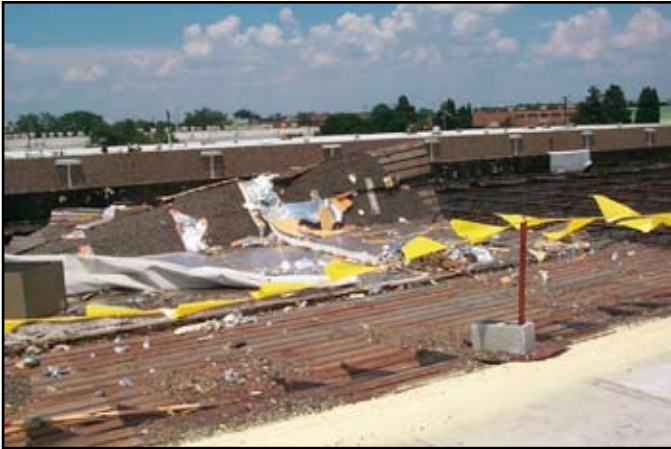
Safety barricades are installed around the areas of missing deck to ensure worker safety.

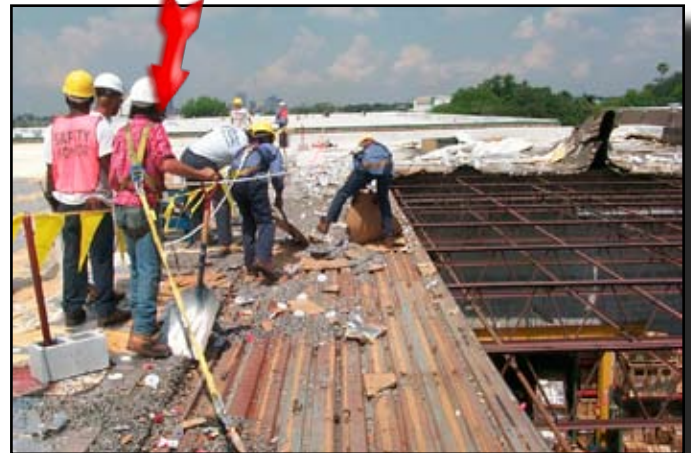
Crew members remove debris from the damaged area. Danger from falling debris was preventing entry into the structure.

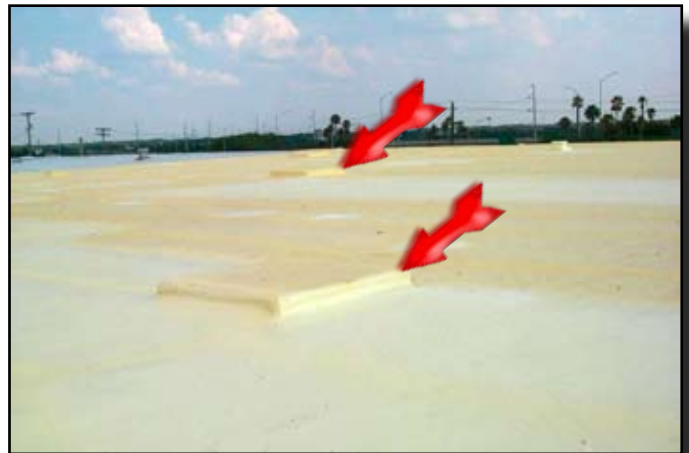
The A/C units were blown off these curbs. Installing plywood over the curbs then completely encapsulating them with SPF easily repairs this condition.

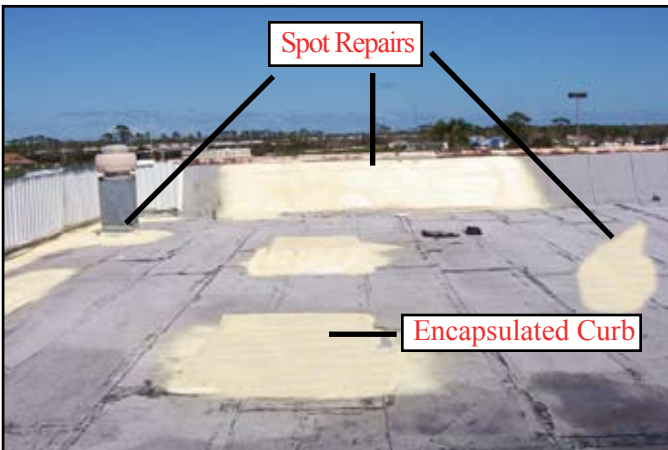
SPF used for spot repairs to a parapet wall and various areas on a modified bitumen. Note the curb that is completely encapsulated (the fan top had blown off.)

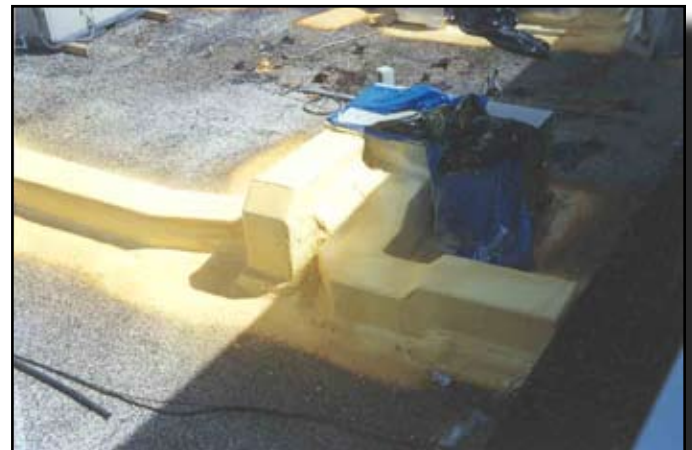
This duct work was crushed in many areas and water was pouring in the building. The entire duct was encapsulated with SPF.

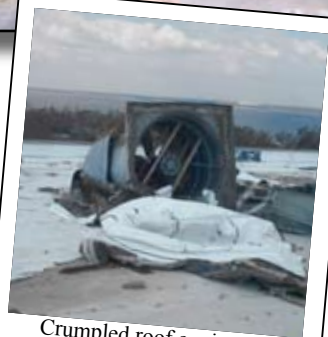
Crumpled roof equipment

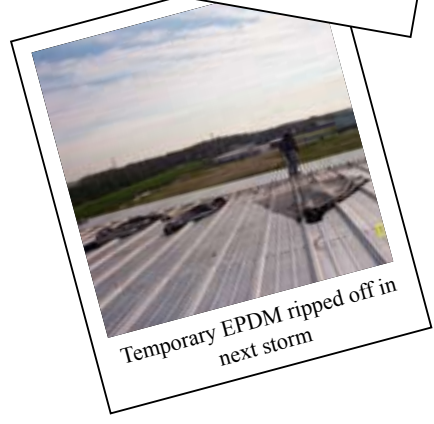
Failed Temporary EPDM

Temporary EPDM ripped off in next storm

During the hurricane, the roof on this office building was extensively damaged and a temporary rubber roof (EPDM) was installed. However, during the next thunderstorm, the large sheets of rubber blew off. The owner then decided on a SPF system which lasted the 8 months it took to special order the specialty metal roof panels to match the existing roof.
