PROACTIVE
*A Hurricane Preparedness Program
for Temporary Re-Roofing*

Installation Process

Service:	Temporary Emergency Roof
Size:	30,000 s.f.
Installation:	2 days
Project:	Commerce Park Distribution Center
Location:	Tampa, Florida
Facility Type:	Distribution Center
Owner:	Prologis

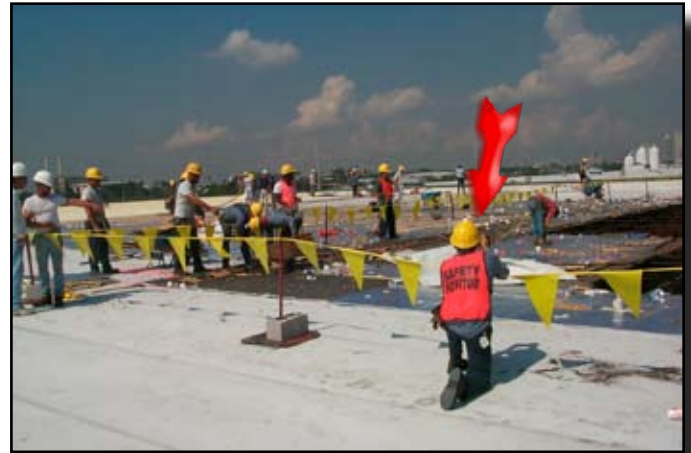
Four full time safety monitors are stationed around the perimeter of the area while crews work around the immediate area of missing deck.

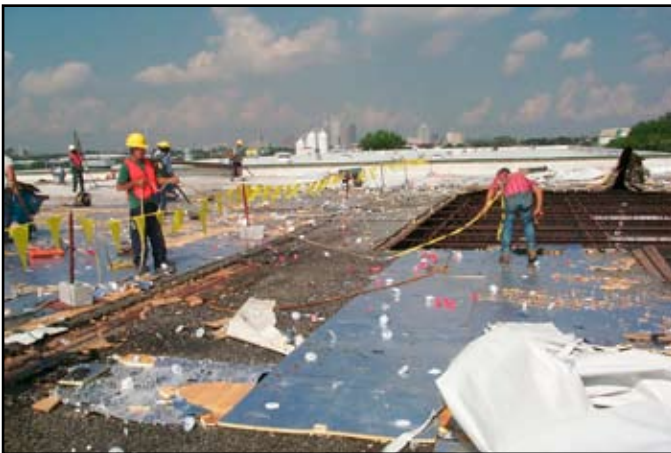
Fall protection is attached to all crew members that are working inside the safety barriers.

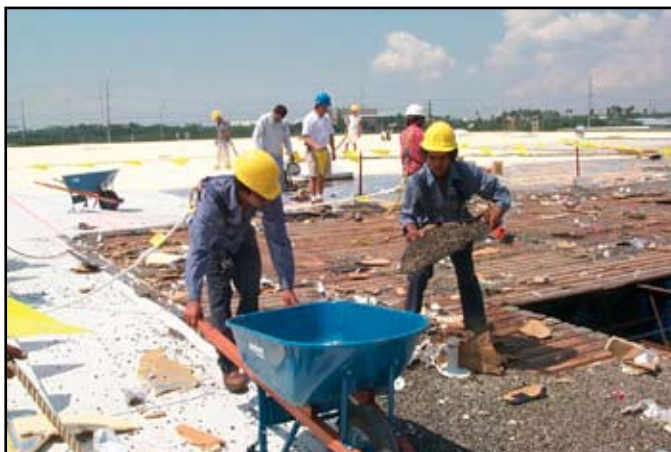
Debris is removed from the rooftop.

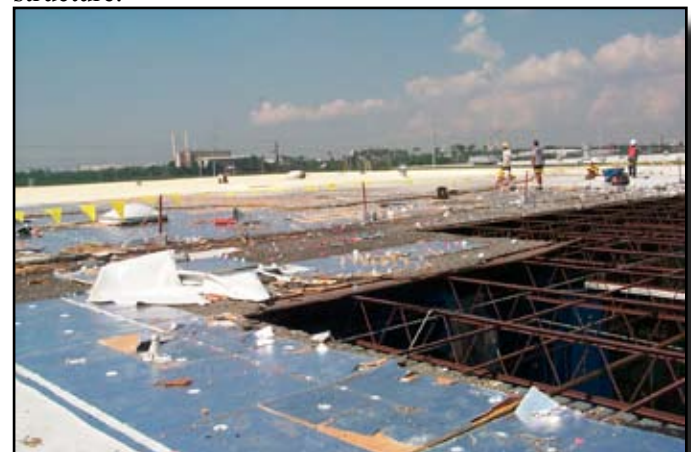
Area around the missing decking is secured and all debris is removed. Entry into the structure is now safe.

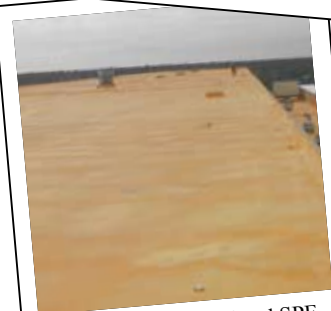
Overview of completed SPF

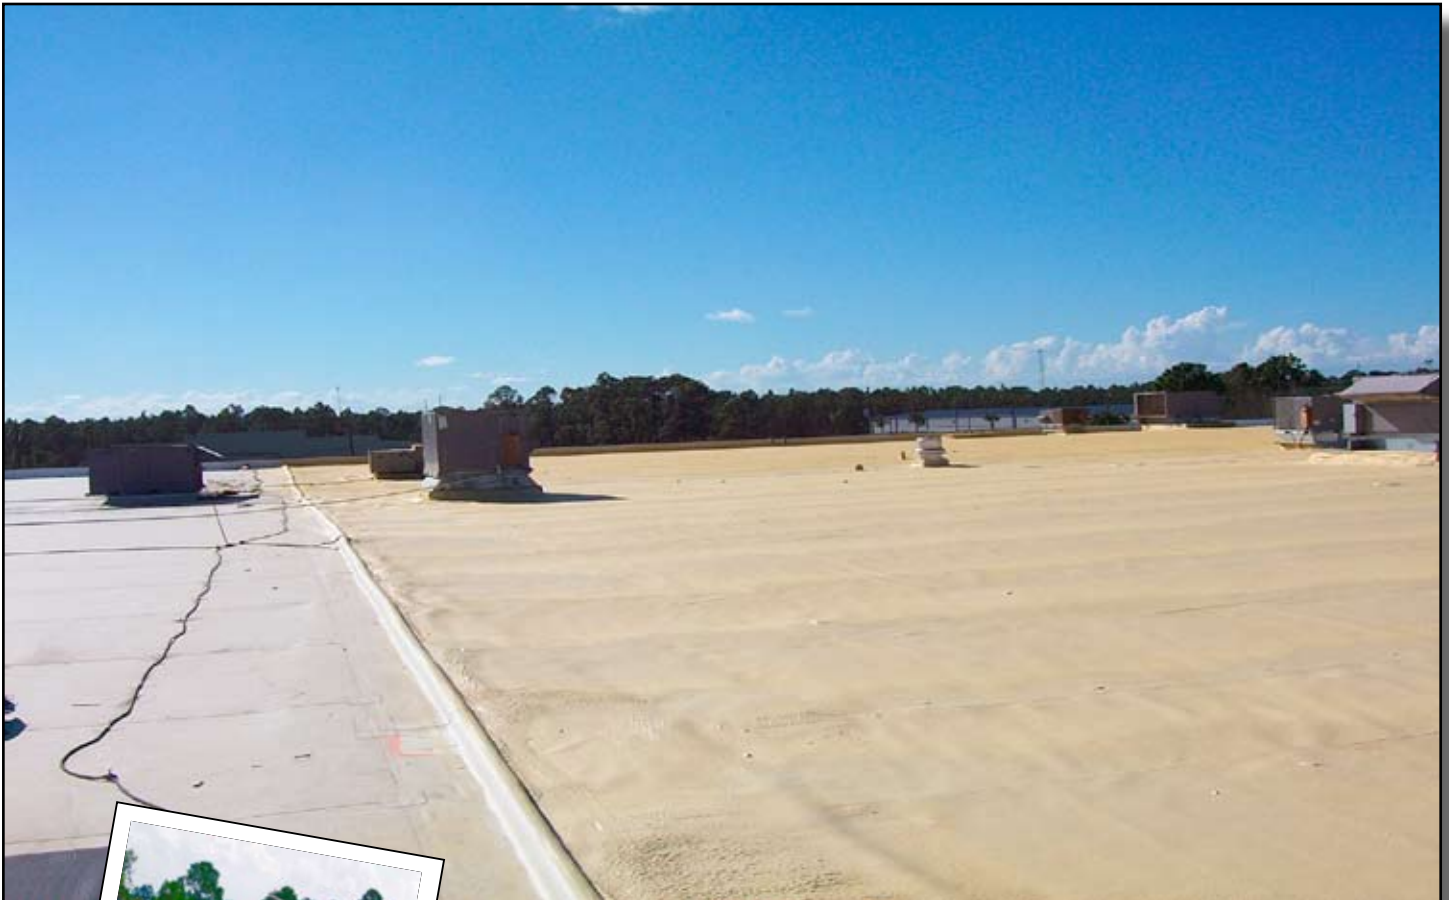
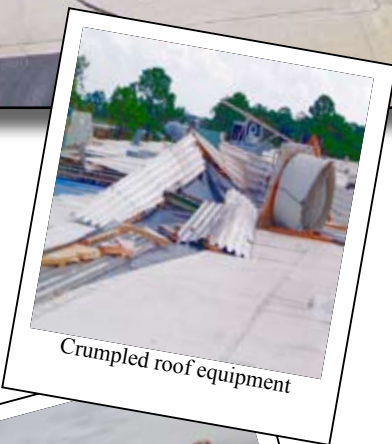
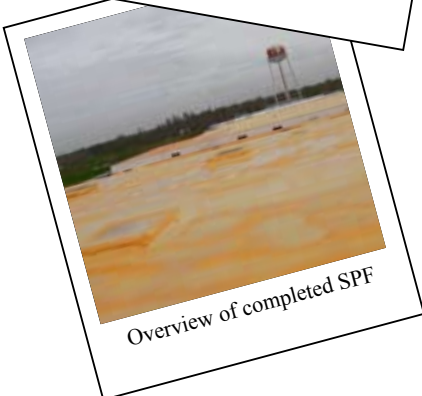
When 100,000 s.f. of GE Energy's roof blew off during hurricane Ivan, their plant was shut down. Since they had a Hurricane Preparedness agreement in place, TarHeel had their plant completely watertight (100,000 s.f.) and back in operations within 4 days of starting the work.

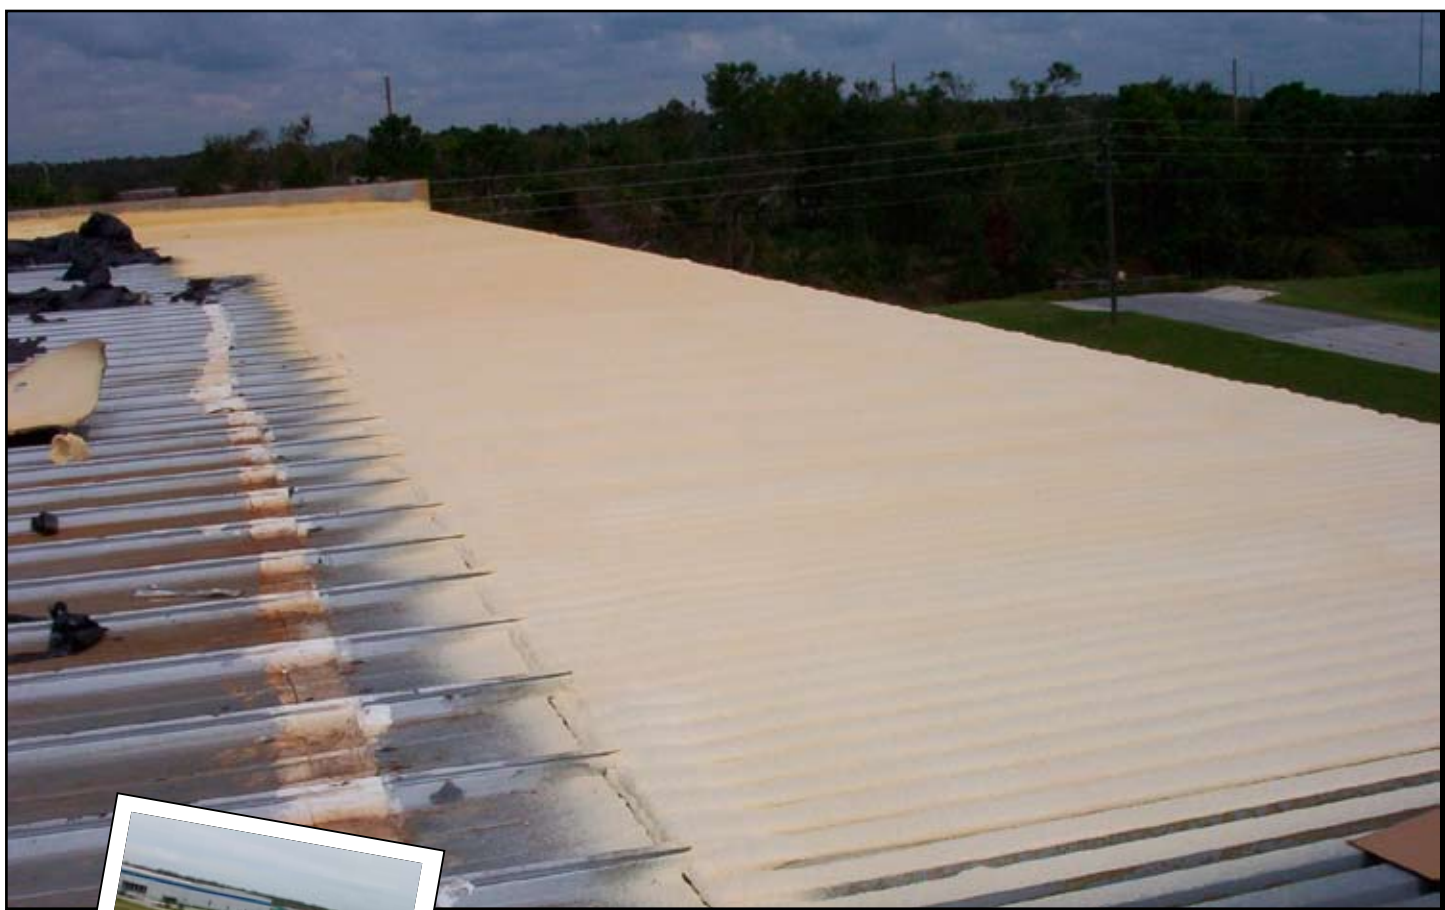
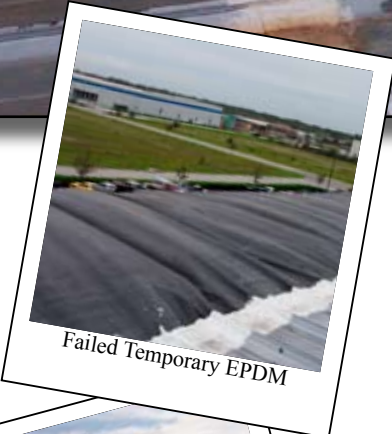
Over 90,000 s.f. of roof blew off and extensive damage occurred to parts of the metal deck. Holes and punctures were prevalent in other roof sections that did not blow off. One benefit of SPF is its ability to act as a repair system. For “blown off” areas, a complete SPF system is installed. Damaged areas with holes and punctures are simply patched with SPF.
